Technical Series 00-103

## STRAW BALE HOUSE MOISTURE RESEARCH

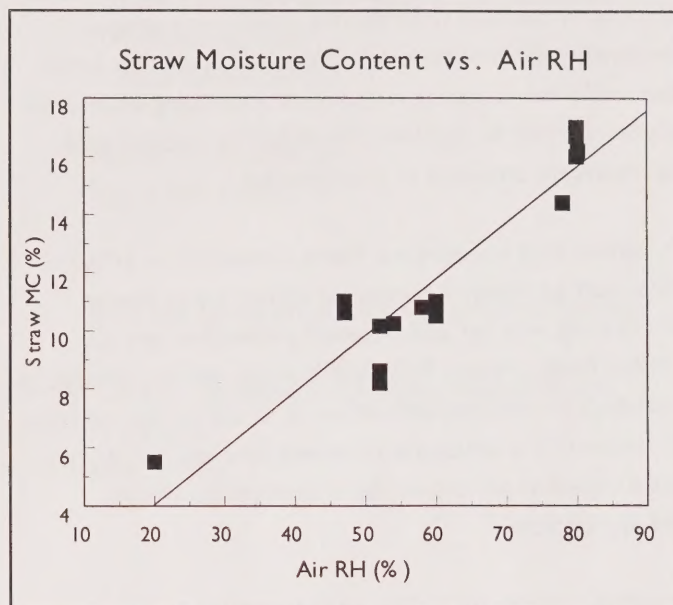
The September readings were generally lower than those at midsummer, at around 11 per cent. These wood moisture contracts in Nova Scotia are roughly the same as the air relative humidities as measured in Alberta. See the graph below for a conversion.

The Nova Scotia results showed similar trends. Researcher Shawna Henderson monitored the Nova Scotia houses using wood blocks and wood moisture meters. All readings, for the middle of bale walls, averaged 10 per cent wood moisture content in May and 12 per cent in July, with a few excursions above 15 per cent.
